Motor Vehicle vs Motorcycle
Colonial Dr / Amber Rd
Orlando, Florida
September 22, 2019

**Final Findings
Report**

**Delta-V
Consulting**

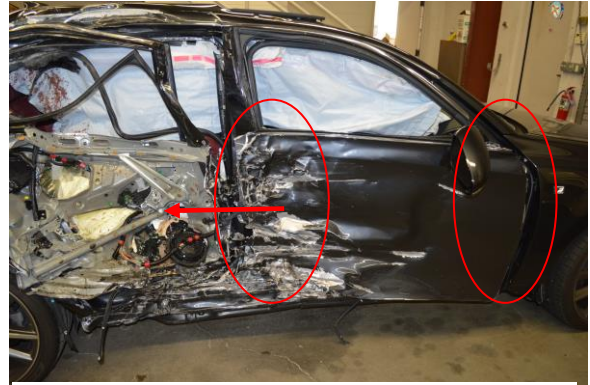
Figure 2

The investigator observed "heavy damage to the right side of V1. Damage observed initiating from the front passenger side door leading rearwards to the rear right door. Heavy damage was seen to the rear right door leading in the front with a 6 inches indentation." The investigator also observed "induced damage to the right rear side of V1 roof concentrated on the top rear edge of the rear right door frame."

The magnitude of the collision traveled through the vehicle from the passenger side toward the driver side, crumpling and raising the roof in the area of the damage.
